An Academic Investigation of the I-35W Bridge Collapse

Roberto Ballarini James L. Record Professor Department of Civil Engineering University of Minnesota

PHM Conference

September 26, 2012

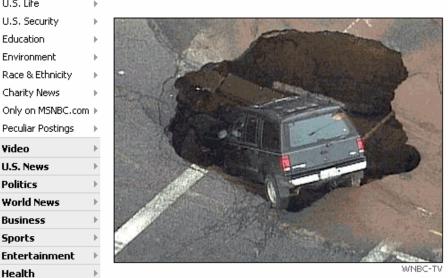
Water main break; SUV sitting on gas main.

The SUV rests in the Brooklyn street sinkhole.

NEW YORK - A city street collapsed under a sport utility vehicle early Monday, leaving the vehicle nose down into a deep sinkhole that officials said was caused by a water main break.

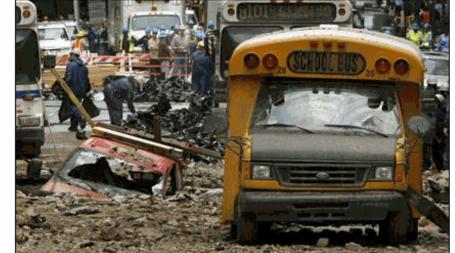
A destroyed tow truck sits in a hole Thursday at the site of an underground steam pipe explosion in New York. The Wednesday explosion tore a crater in Lexington Avenue near Grand Central Terminal, sending residents running for cover amid a towering geyser of steam.

> 83 years old steam pipe, and part of a system put into service in 1882!!!

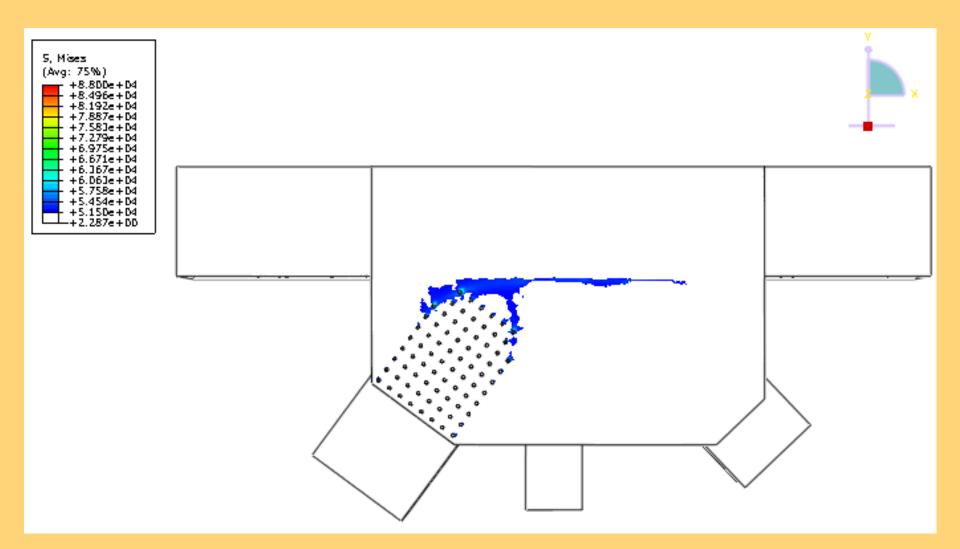
Plastic deformation resulting from increase of slab thickness from 6.5" to 8.5"

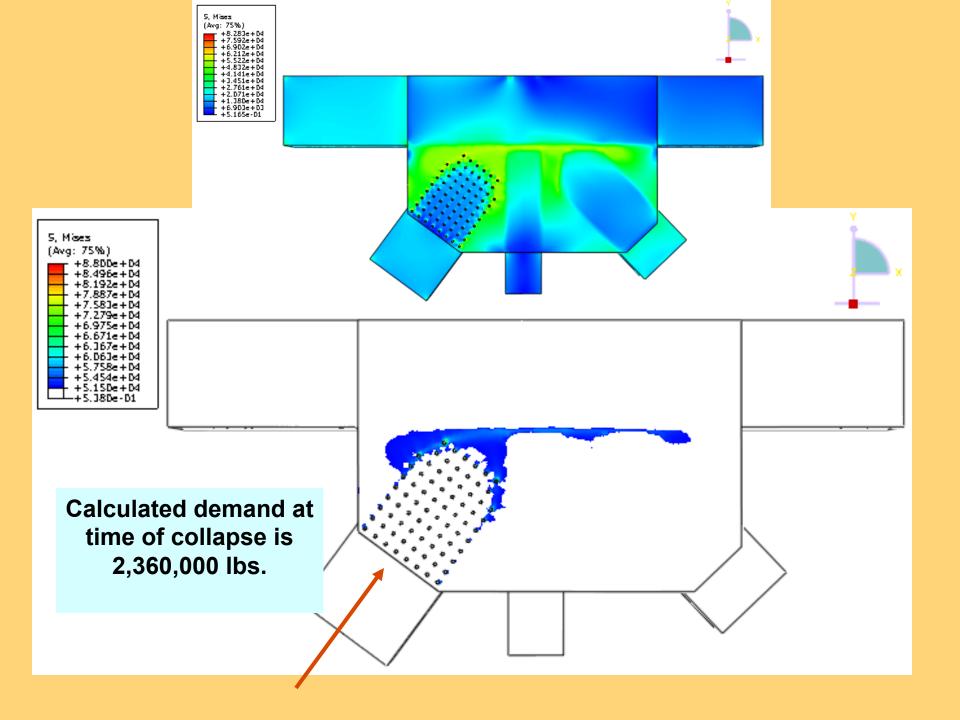
Plastic deformation resulting from averaged traffic load added to 8.5" deck

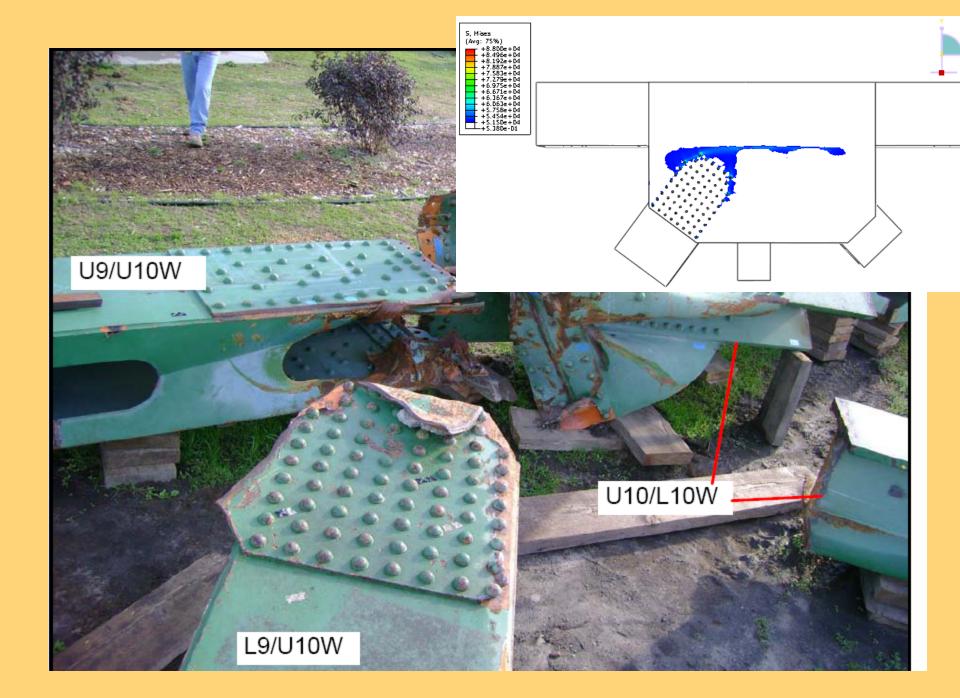
Plastic deformation resulting from addition of 30°F temperature differential from one side of joint to the other

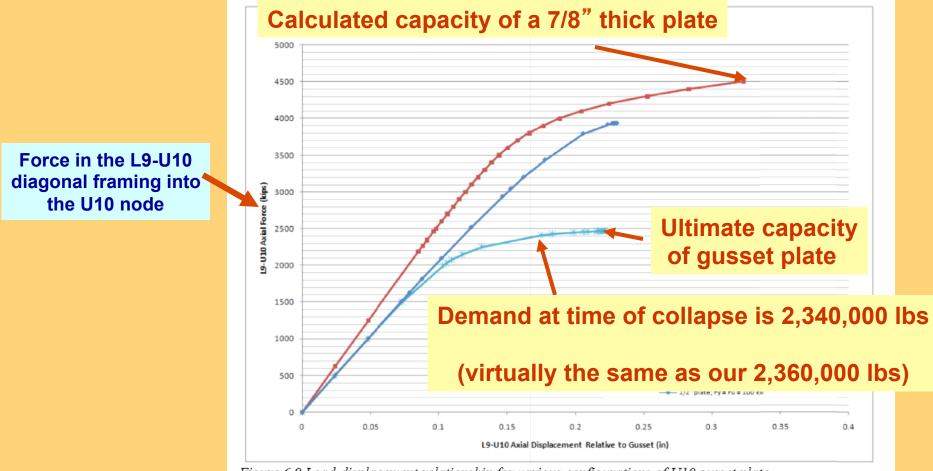
Figure 6.9 Load-displacement relationship for various configurations of U10 gusset plate.

With respect to the design service loads, the safety factor of the gusset plates at nodes U10 was approximately equal to 1.0, instead of the roughly 2.0 required by the requirements of the design code in 1967. For unexplained reasons, these plates were ½" instead of 1" thick.

The bridge collapsed as a result of the failure of the gusset plate(s) at a U10 node, in the vicinity of the L9-U10 compression diagonal. The calculated capacity of the gusset plates (that failed) was very close to the demands that were placed on it at the time of the bridge collapse. Had the plates been 1" thick, the capacity would have exceeded the demands.

A comparison of our results with those In the WJE report
