# Fabrication of a Multi-Physics Integral Structural Diagnostic System Utilizing Nano-Engineered Materials

Seth S. Kessler<sup>1</sup>, Ajay Raghavan<sup>1</sup>, Christopher T. Dunn<sup>1</sup>,  
Sunny S. Wicks<sup>2</sup>, Roberto Guzman deVilloria<sup>2</sup> and Brian L. Wardle<sup>2</sup>

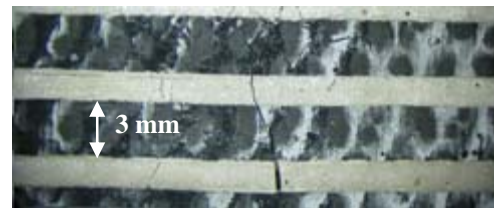
Figure 3: Photograph under microscope of impacted region of FFRP laminate. Painted silver electrodes are 1.5 mm wide and spaced 3 mm edge-to-edge.

Initially a single FFRP laminate (114 x 25 x 3 mm) was tested to prove the concept. Silver-ink electrodes were painted onto the specimen surfaces using simple tape masks (Figure 3). On the top plate surface, 14 parallel conductors were patterned in the short-dimension. On the opposite surface, 4 parallel conductors were patterned in the long dimension (so that they were perpendicular to the top side conductors through the thickness). These traces were all 1.5 mm wide and spaced 3 mm edge-to-edge. Prior to testing, the electrical resistance was measured using a Fluke 189 model multimeter with resolution 0.01  $\Omega$  and accuracy of  $\pm 0.05\%$ . Initial data showed significant variability when probing directly on the silver traces. Subsequently, a procedure was developed to bond thick gauge wires to the traces using silver epoxy, resulting in  $< 1\%$  change ( $< 0.1 \Omega$  for  $\sim 10 \Omega$  trace) across 10 repeat trials. The specimen was centrally impacted with a 13 mm diameter steel ball at using a guided dropped weight to initiate damage. Following impact, post-damage resistance measurements were collected again for each possible combination.

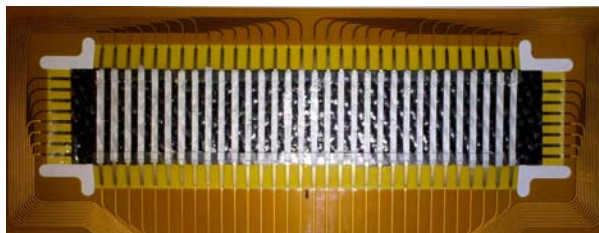
Figure 4: Photograph of flex-frame with FFRP sample

Next, rather than using soldered wires connect to the traces, a single double-sided copper-coated-Kapton w/coverlay flexible circuit was designed to make connections with the direct-write (DW) traces. In a processes developed by the investigators during the course of separate research, the flex circuit was bonded to the specimens first, then the DW traces were applied onto the specimens, including overwriting the flex-circuits (which included alignment marks). The flex circuit was designed in the shape of a rectangular frame, with flaps on all 4 inside edges with exposed pads for the DW process. The specimens fit inside the frame window with the top and bottom flap overlapping onto the front of the FFRP, and the left and right flap overlapping on the back of the FFRP. Traces are then routed along the edges of the frame to an 80 pin connector located on a bottom tab for hardware connection. This “flex-frame”, as seen in Figure 4, provides reliable, durable and consistent electrical continuity from traces to hardware, specifically because it eliminates all contract resistance issues. Finally, a PCB was designed to mate with this flex-frame, containing switches to multiplex the channels and simple and reliable connections for a multimeter probe and PC readout. After being instrumented, each FFRP specimen was progressively impacted at 15, 30 and 45 ft-lbs, using the same guided dropped weight setup, with in-and-out-of-plane resistance measured after each subsequent impact.
